**FINAL REPORT
ROUND 7 DAM ASSESSMENT - WISCONSIN POWER & LIGHT
COLUMBIA GENERATING STATION
PRIMARY ASH, SECONDARY ASH, POLISHING & LANDFILL
STORMWATER PONDS
PARDEEVILLE, WISCONSIN**

June 2, 2011

Re: Round 7 Dam Assessment - Final Report
EPA Contract No. EP10W001313
Wisconsin Power & Light – Columbia Generating Station
Primary Ash, Secondary Ash, Polishing & Landfill Storm Water Ponds
Pardeeville, Wisconsin

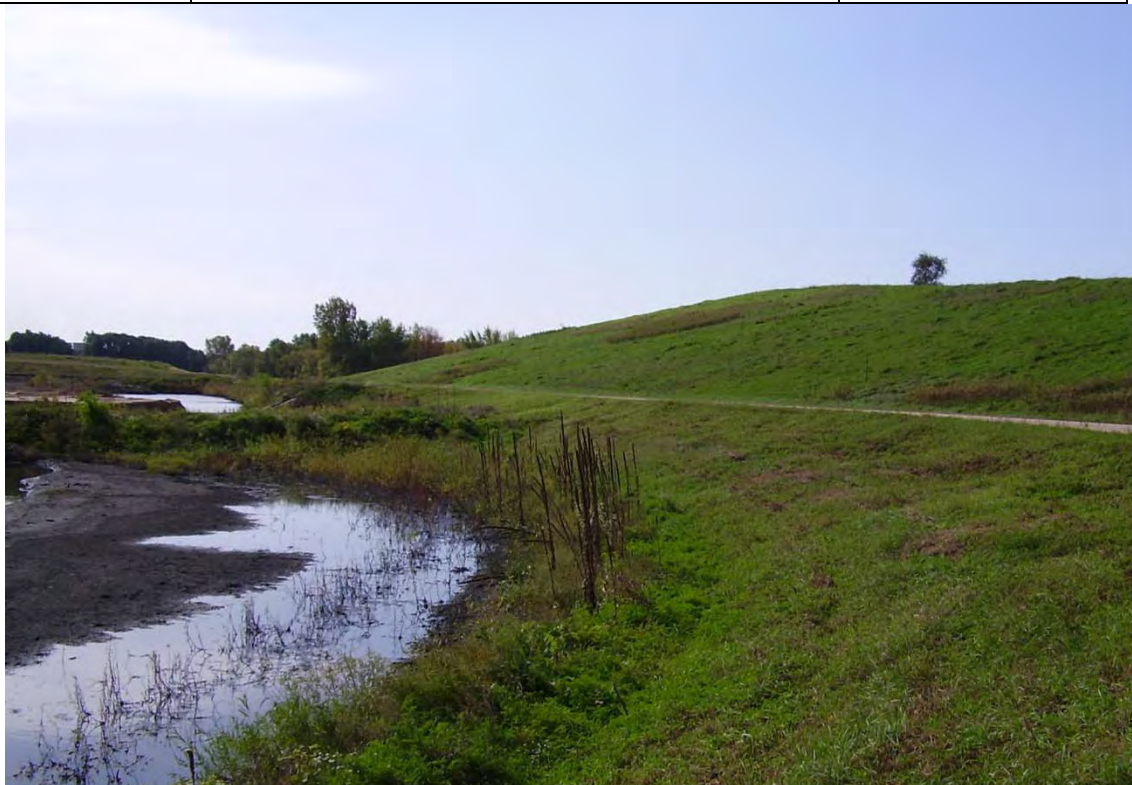
Description:
Upstream slope of Primary
Ash Pond Impoundment
(PAP).

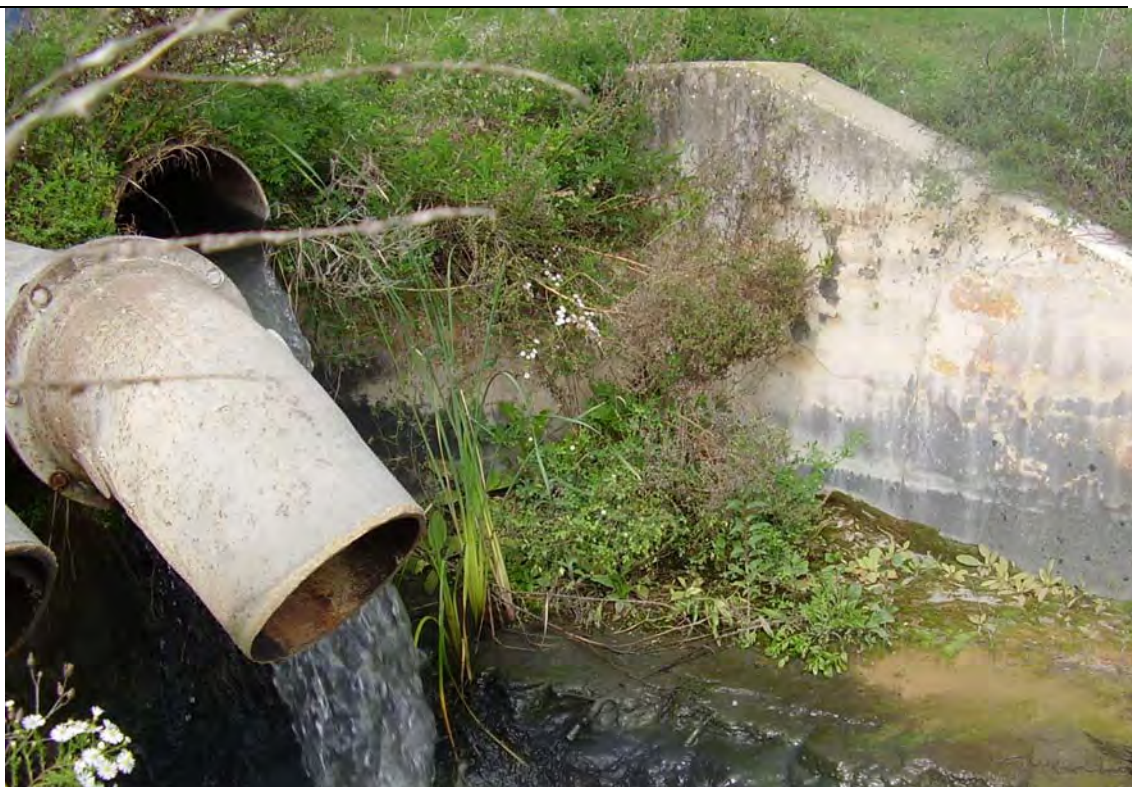
Description:
Discharge Pipeline (behind
12" Diameter pipeline):
(1) 18" Diameter in PAP

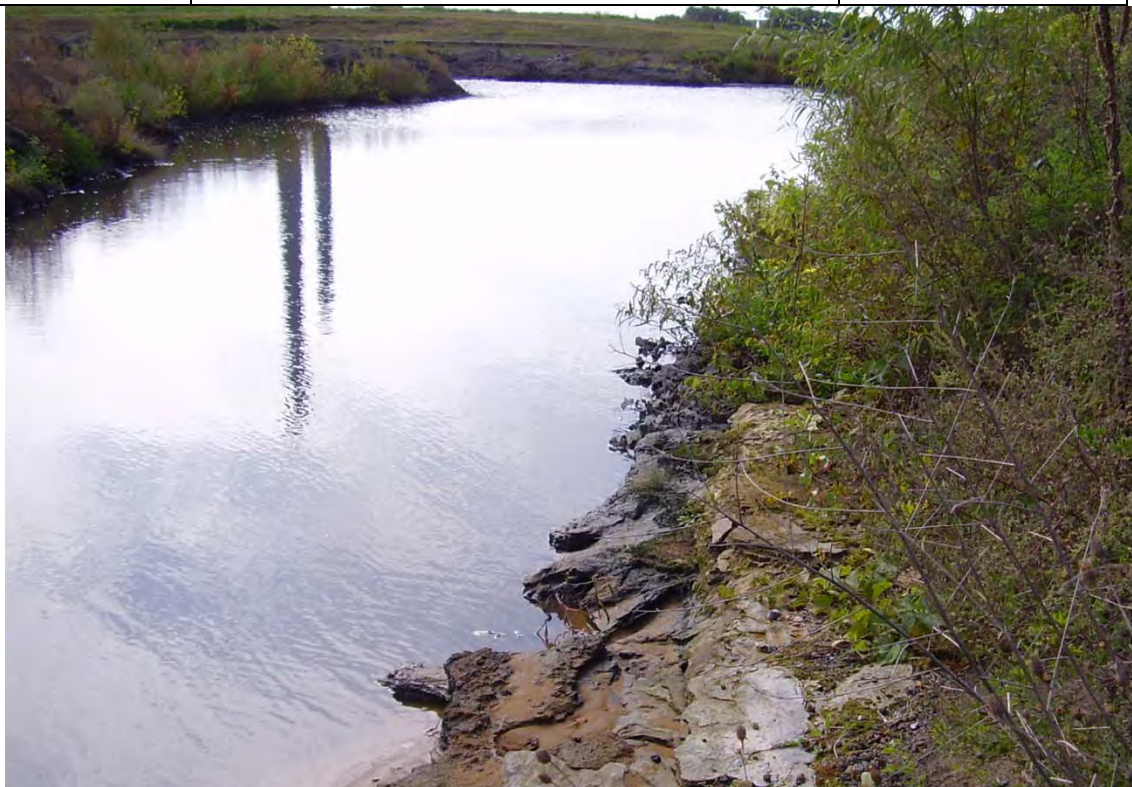
Description:
Upstream slope of PAP.

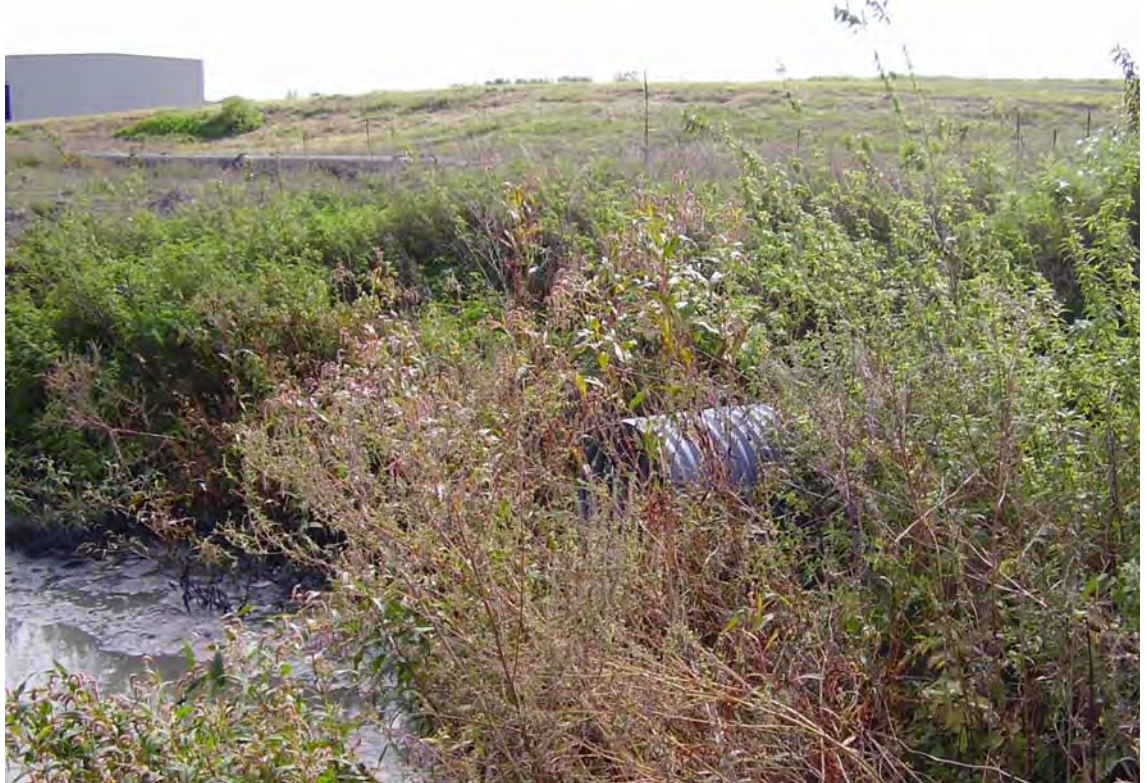
Photo No.
8

Description:
Upstream slope of PAP, ash
recovery operations, and
discharge pipelines.

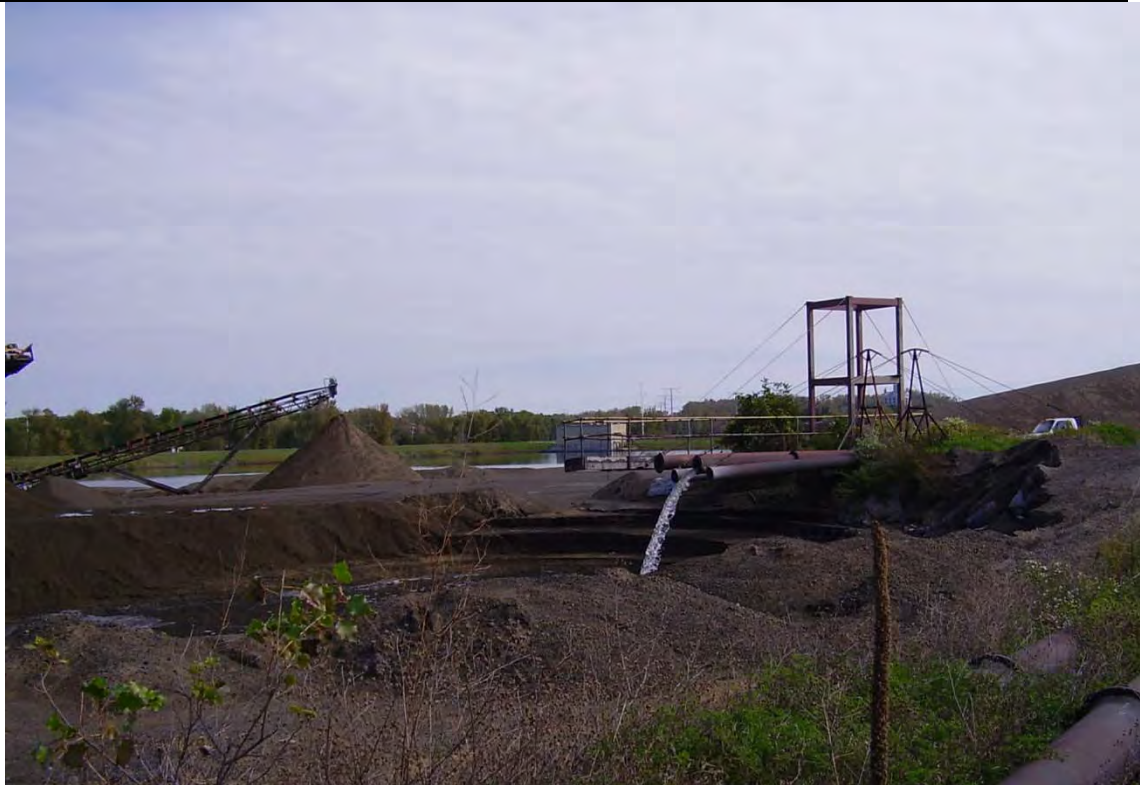
Photo No.
10

Description:
Upstream slope of PAP.

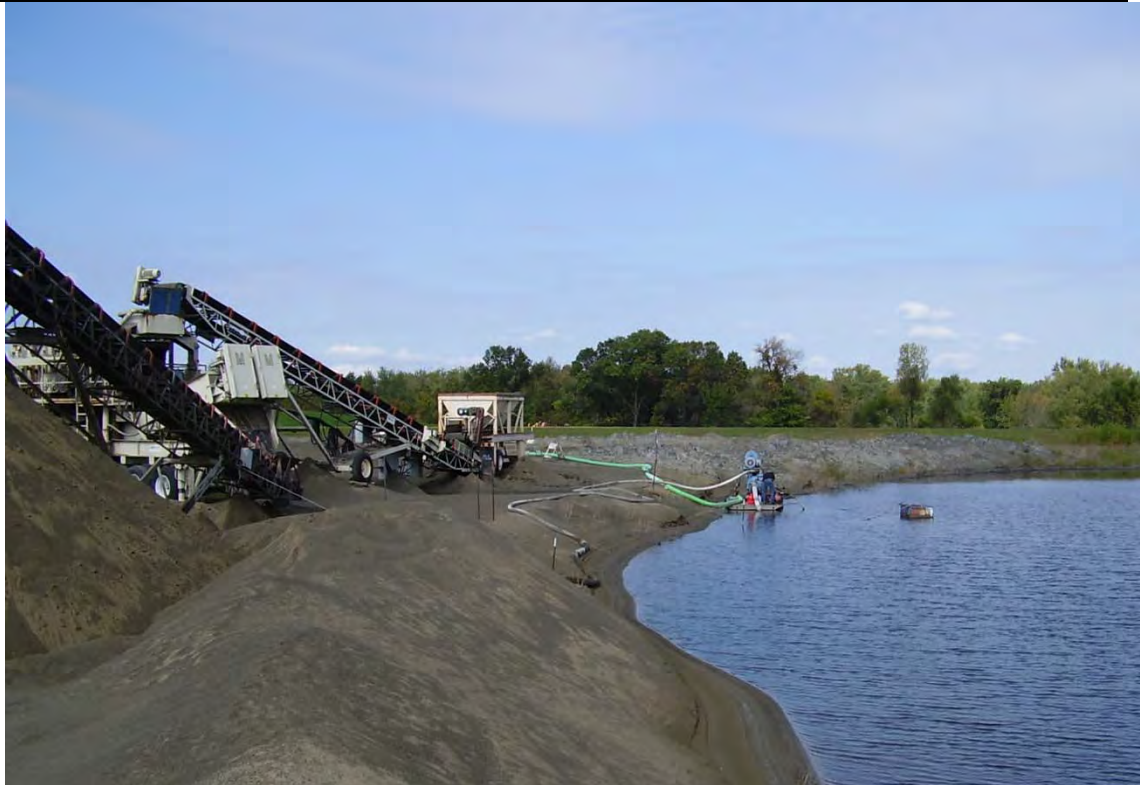
Photo No.
12

Description:
Upstream slope of PAP.

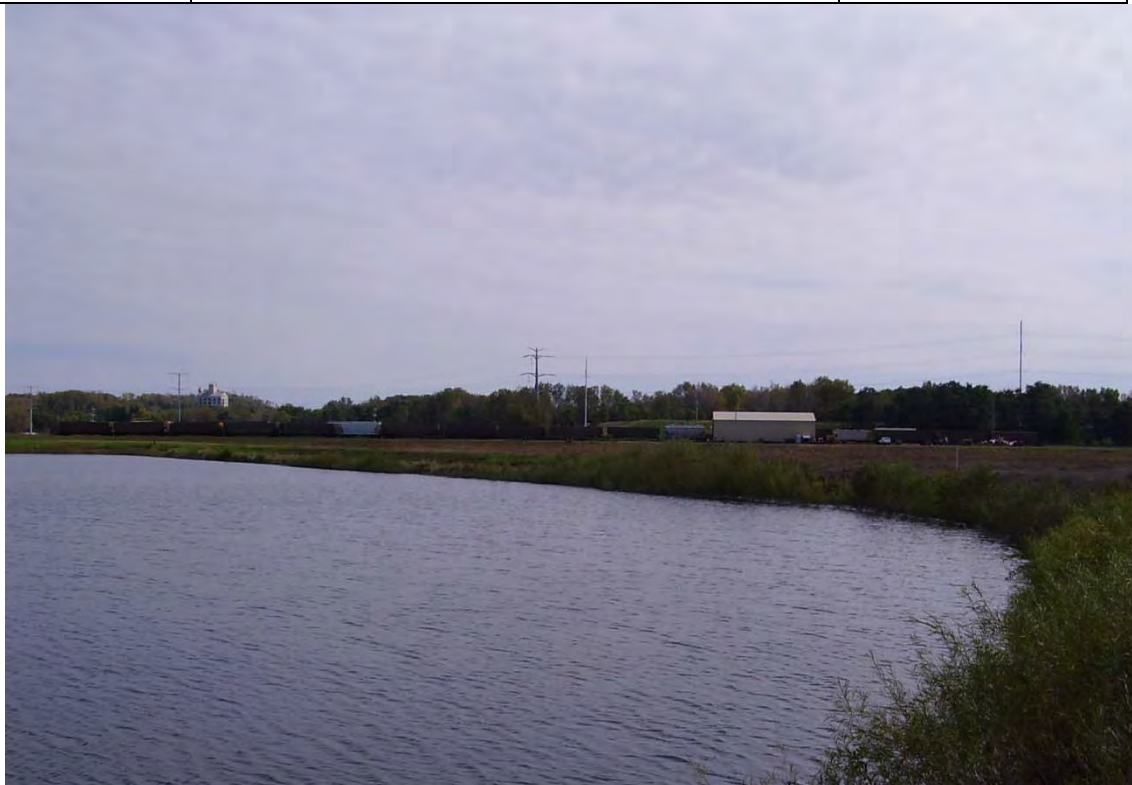
Photo No.
14

Upstream slope of PAP,
downstream slope of SAP
and PAP pump house.

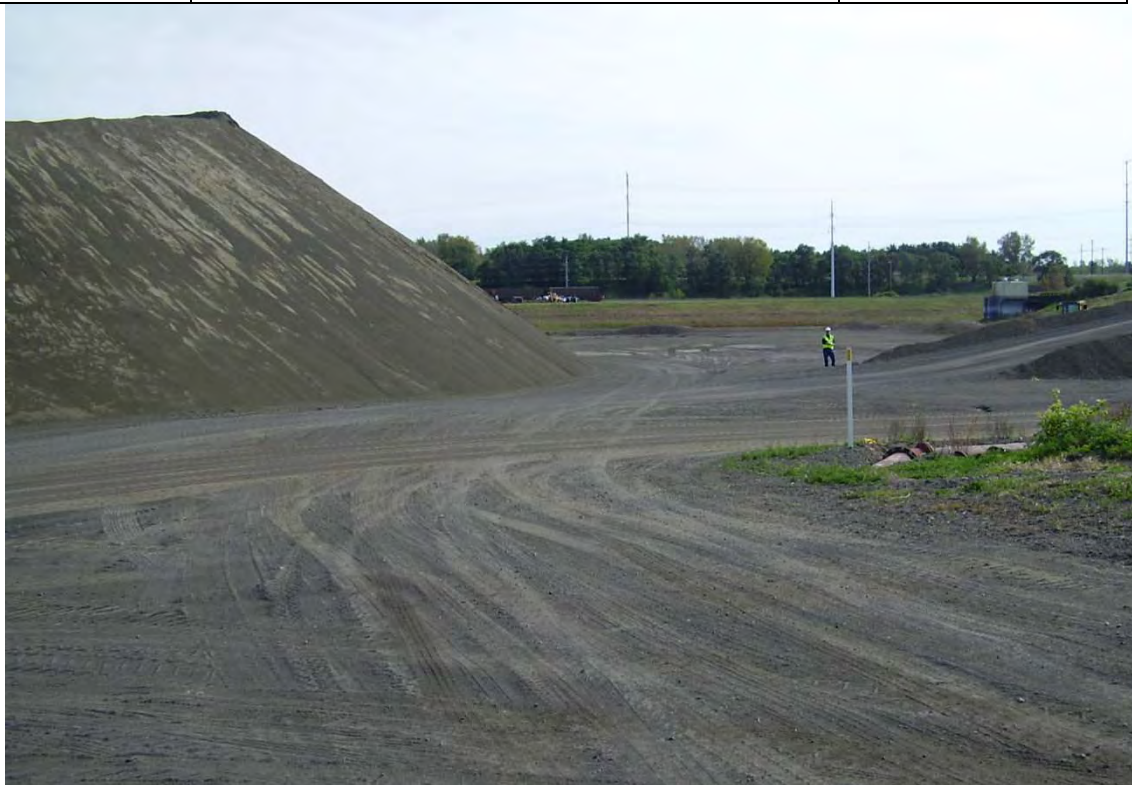
Photo No.
22

Description:
Crest of PAP.

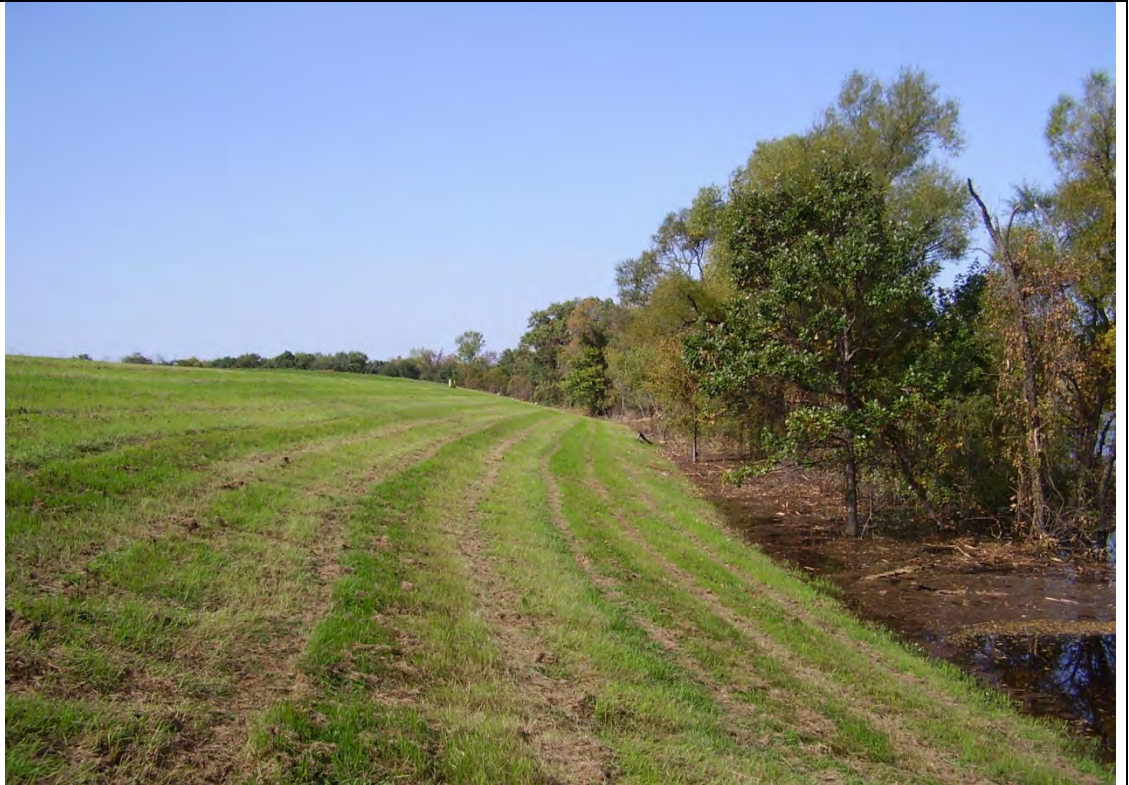
Photo No.
26

Description:
Downstream slope of PAP

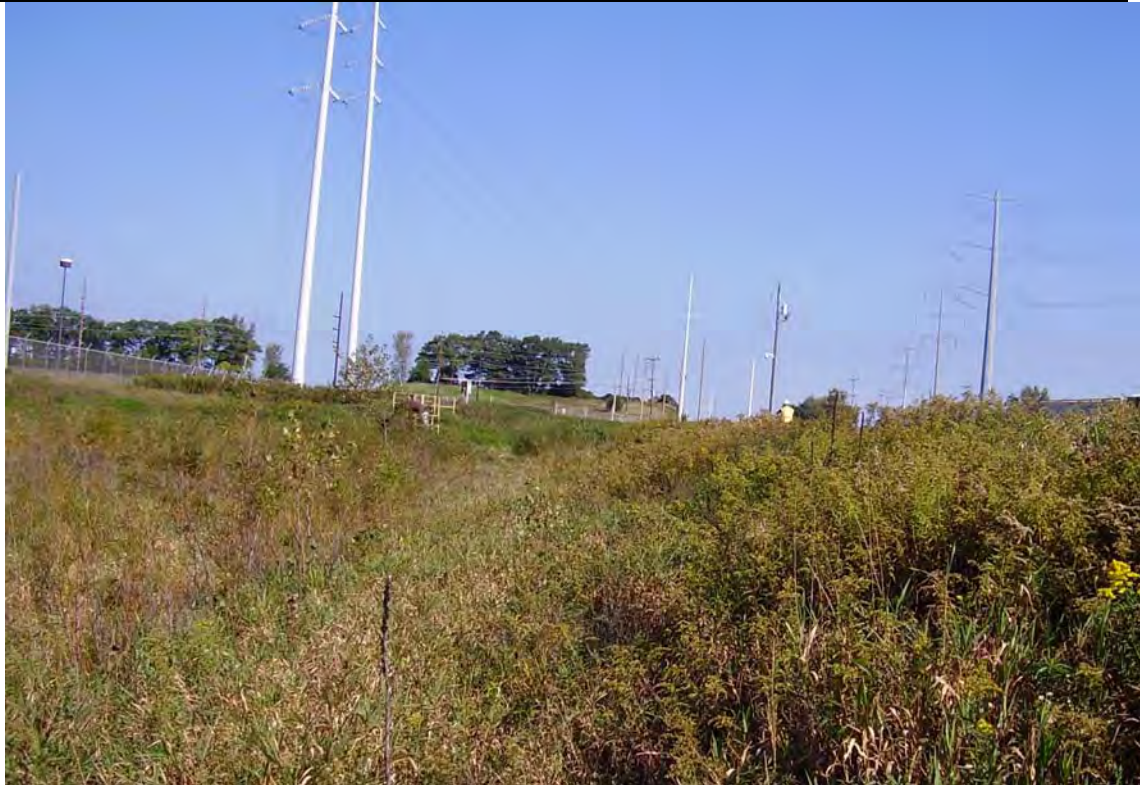
Photo No.
52

Description:
Upstream slope of PP and
(1) 8" inlet pipe.

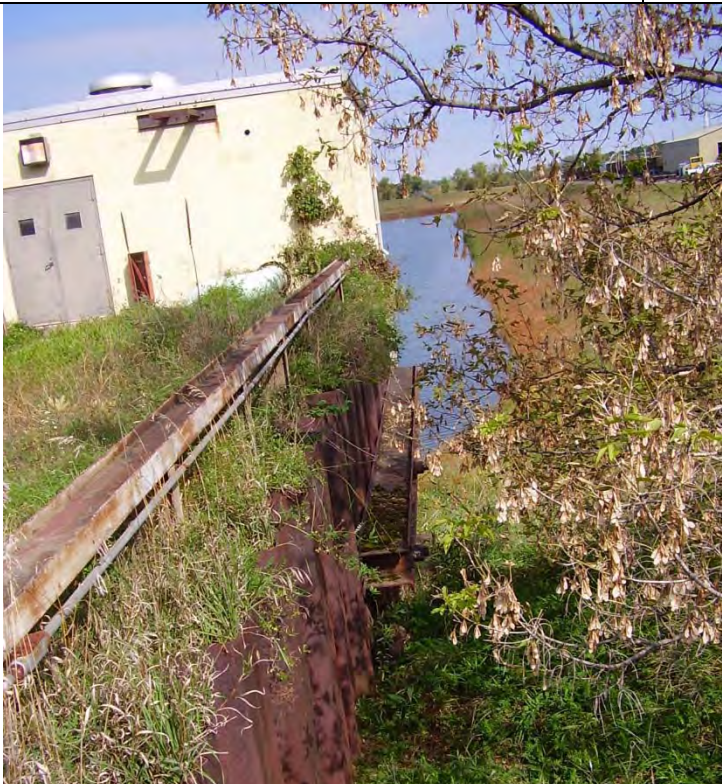
| Description: SAP pump house. | | | |
